INVESTIGATION OF THE CHALLENGER ACCIDENT

OCTOBER 29, 1986.—Committed to the Committee of the Whole House on the State of the Union and ordered to be printed

Mr. FUQUA, from the Committee on Science and Technology,
submitted the following

R E P O R T

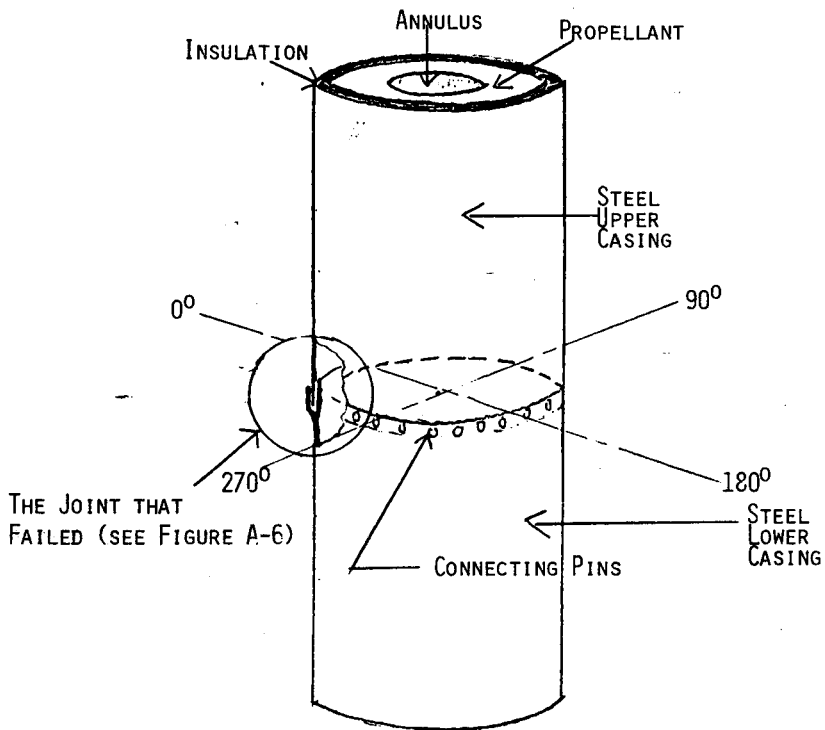
FIGURE V-5

Considerable reference will be made to the "joint design" throughout this section of the report. Consequently, the following description of the joint is provided. (See Figures V-5 thru V-7.)

A. JOINT IN NORMAL ALIGNMENT
(NO GAPS BETWEEN O-RINGS AND TANG)
